Investigation and hazard assessment of the 2003 and 2007 Staircase Falls rock falls, Yosemite National Park, California, USA

G. F. Wiecek¹, G. M. Stock², P. Reichenbach³, J. B. Snyder⁴, J. W. Borchers⁵, and J. W. Godt⁶

Abstract. Since 1857 more than 600 rock falls, rock slides, debris slides, and debris flows have been documented in Yosemite National Park, with rock falls in Yosemite Valley representing the majority of the events. On 26 December 2003, a rock fall originating from west of Glacier Point sent approximately 200 m³ of rock debris down a series of joint-controlled ledges to the floor of Yosemite Valley. The debris impacted talus near the base of Staircase Falls, producing fragments of flying rock that struck occupied cabins in Curry Village. Several years later on 9 June 2007, and again on 26 July 2007, smaller rock falls originated from the same source area. The 26 December 2003 event coincided with a severe winter storm and was likely triggered by precipitation and/or frost wedging, but the 9 June and 26 July 2007 events lack recognizable triggering mechanisms. We investigated the geologic and hydrologic factors contributing to the Staircase Falls rock falls, includi

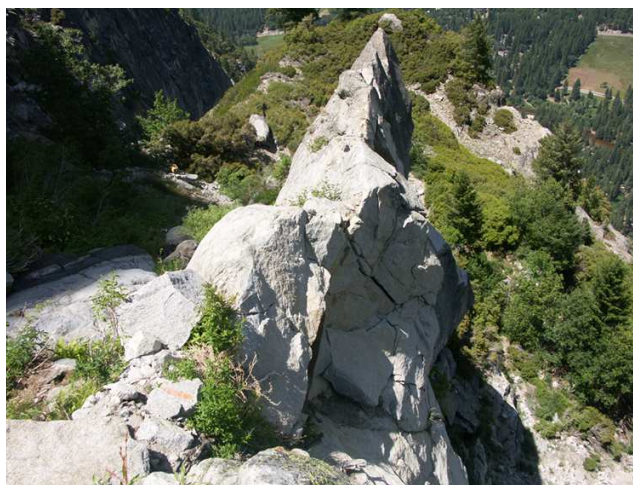
Fig. 3. Staircase Falls rock-fall detachment area, showing narrow projecting bedrock fin. 2003 and 2007 rock falls occurred from center-right side of fin. Floor of Yosemite Valley 555 m below is in upper right of photograph. Staircase Creek flows down left (south-west) side of fin before turning sharply right (northeast) around the base of fin to top of Staircase Falls.

Subsequent observation of the detachment area in April 2004 revealed additional potentially unstable rock in the form of a fractured, jointed, and moderately weathered bedrock fin (Fig. 3). We estimated the volume of potentially unstable rock remaining at the detachment area, in the form of the narrow bedrock fin (Fig. 3), to be $\sim 350\text{ m}^3$. Only a few meters of rock separate the Staircase Creek channel in LeConte Gully from the active detachment surface of the Staircase Falls source area (Fig. 3).

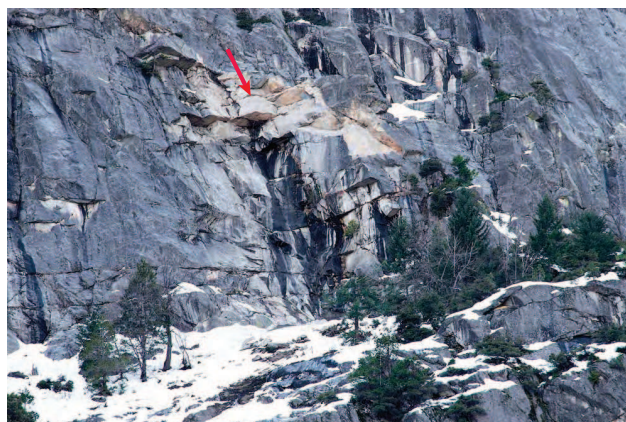
Fig. 4. Photograph of Staircase Falls rock-fall detachment area taken 21 days after 26 December 2003 event, showing light colored joint-controlled detachment surfaces. Rock debris impacted snow-covered ledge immediately below source area, and then fell $\sim 745\text{ m}$ down joint-controlled ledges to Yosemite Valley floor. Note heavy dark drainage paths below detachment area indicating water flow through joints. Overhanging rectangular block in center left of photograph (marked by red arrow) fell during 9 June 2007 rock fall. (Photo by Dan Horner, NPS).

of the Staircase Falls source area taken 21 days after the 26 December 2003 rock fall showed water streaming from joints below the source area (Fig. 4). Water discharging from the source area is adequate to support perennial hydrophytic vegetation. Each failure from the Staircase Falls detachment area decreases the width of the bedrock fin between LeConte Gully and Staircase Creek, potentially increasing infiltration from Staircase Creek through the fin, and also permitting winter ice to form deeper in the cliff face. Each failure thus accelerates joint weathering in this fin, increasing the probability of future rock falls from this location.

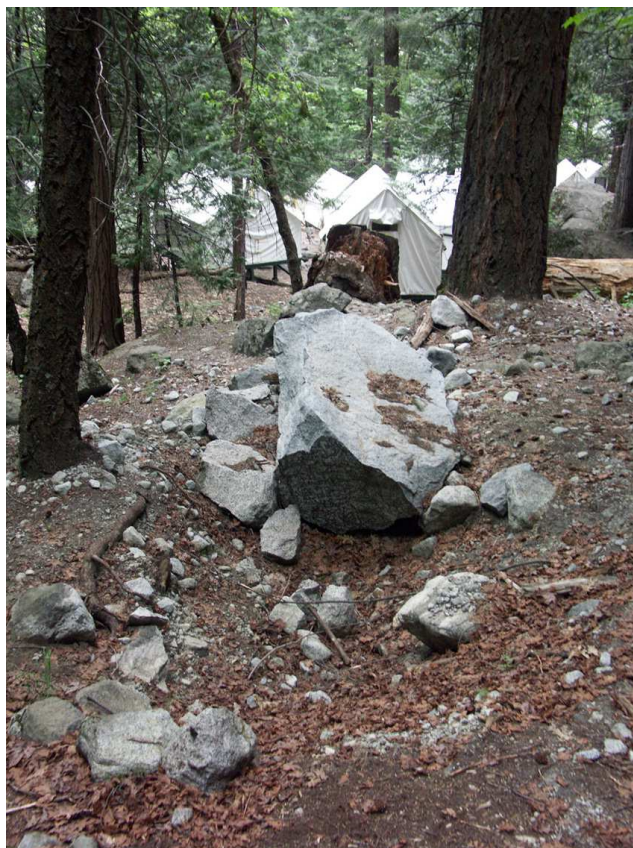
Fig. 5. Part of rock-fall deposit from 26 December 2003 Staircase Falls rock fall. 4 m^3 (11 metric tons) block landed $\sim 120\text{ m}$ beyond base of cliff, leaving prominent impact crater.

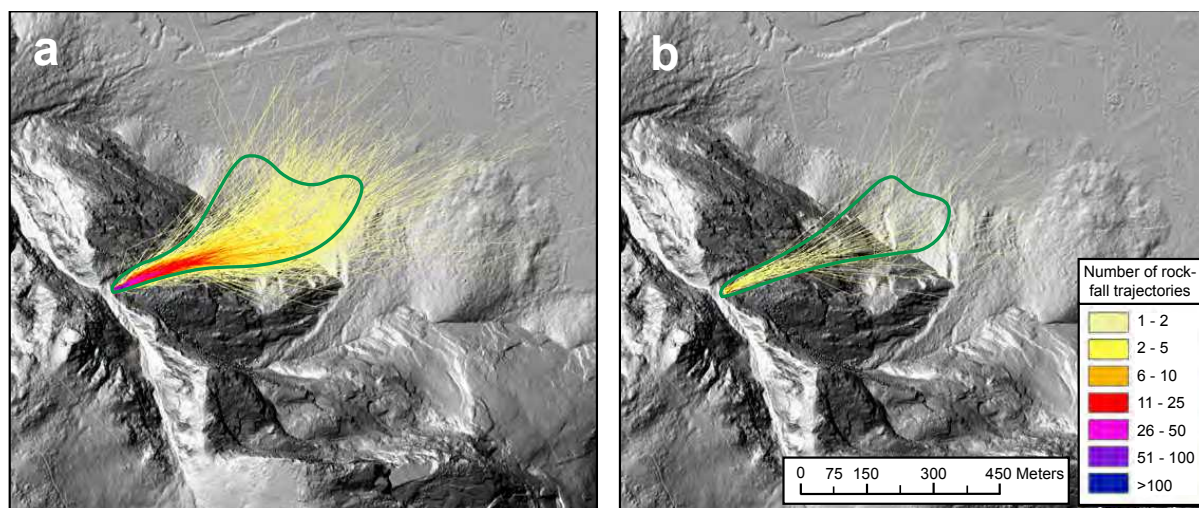
Fig. 11. Comparison of STONE model simulations and mapped extent of rock debris for 2003 and 2007 Staircase Falls rock falls. Colors show number of rock-fall trajectories. **(a)** Simulation of 26 December 2003 rock fall, with 10 blocks launched from each DEM cell of detachment area (112 cells) for total of 1120 rock fall trajectories. Mapped limit of actual rock debris (excluding flyrock) shown by green line. **(b)** Simulation of 9 June 2007 rock fall, with 1 block launched from each DEM cell of detachment area (112 cells) for total of 112 rock fall trajectories. Mapped limit of actual rock debris (excluding flyrock) shown by green line.

Using the 1 m DEM, we then simulated the 26 December 2003 and 9 June 2007 rock falls and compared the results with the actual distribution of rock debris mapped in the field (Fig. 11a, b). Overall, the simulated rock-fall trajectories match well the actual mapped distribution of rock debris, with the majority of simulated trajectories falling within the zone of actual rock debris deposition. Furthermore, many observed dynamics of the Staircase Falls rock falls are displayed in the simulations, including the strong influence on trajectories of the east-trending J2 joint surfaces below the detachment area and the morphology of the talus slope (Fig. 11a, b). For both the 2003 and 2007 event simulations, a small number of trajectories extended farther from the base of the cliff than the mapped distribution of rock debris (Fig. 11a, b). This apparent “overshoot” of the simulated trajectories may be due to several factors. First, some values we assume for input data may not accurately represent the range of rock-dynamics (e.g., Lan and Martin, 2007); although we have assumed reasonable values for these input parameters (Lan and Martin, 2007; Chau et al., 2002), specifically calibrated to Yosemite Valley rock falls (Guzzetti et al., 2003), we cannot empirically verify them, resulting in some uncertainty. Second, STONE does not account for certain factors such as block shape, air drag, block fracturing, and/or energy dissipation by vegetation in the impact zone. Although the filtered (bare earth) 1 m DEM is a substantial improvement over the previously available 10 m DEM, even
